A Stair in the Air

Southern yellow-pine treads hide welded-steel brackets that make these stairs appear to float in space

BY GLEN STEWART

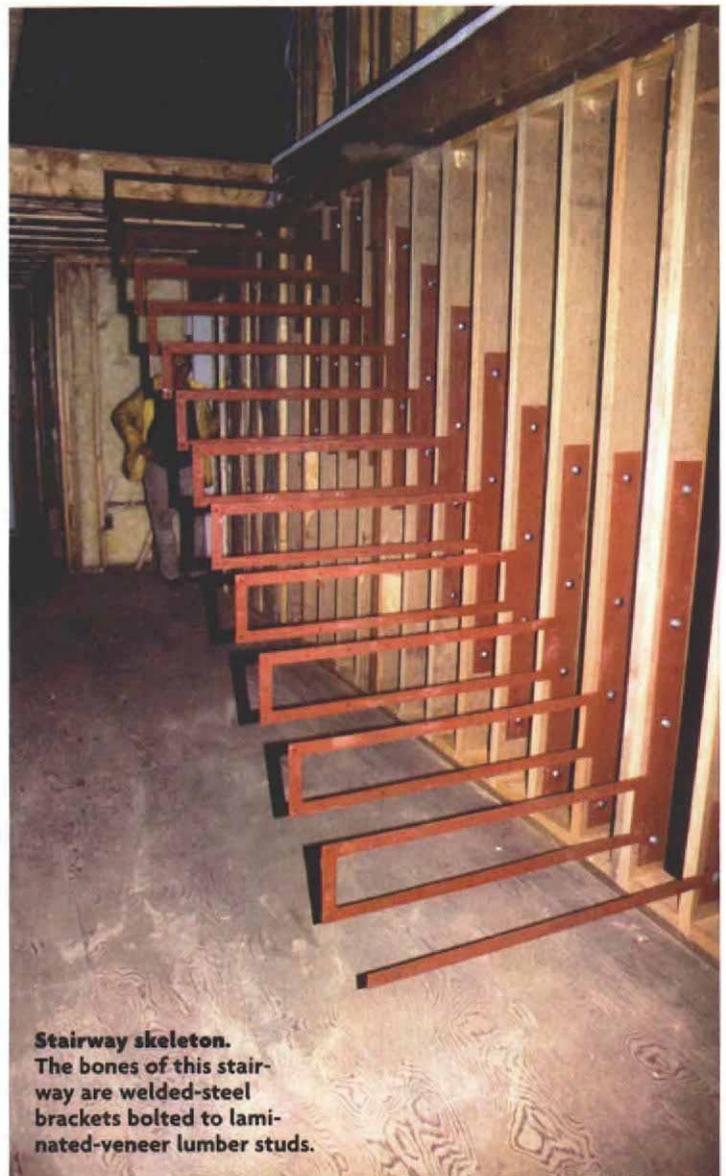
Stairway skeleton.
The bones of this stairway are welded-steel brackets bolted to laminated-veneer lumber studs.

Likewise, the steel frames had to be bolted carefully to each LVL stud to produce the $7\frac{3}{16}$ -in. rise (photo p. 71). After a painstaking installation of the studs and steel brackets, we bolted temporary treads in place and went away while the real work was being done. God bless all electricians, plumbers, plasterers, floor guys and painters.

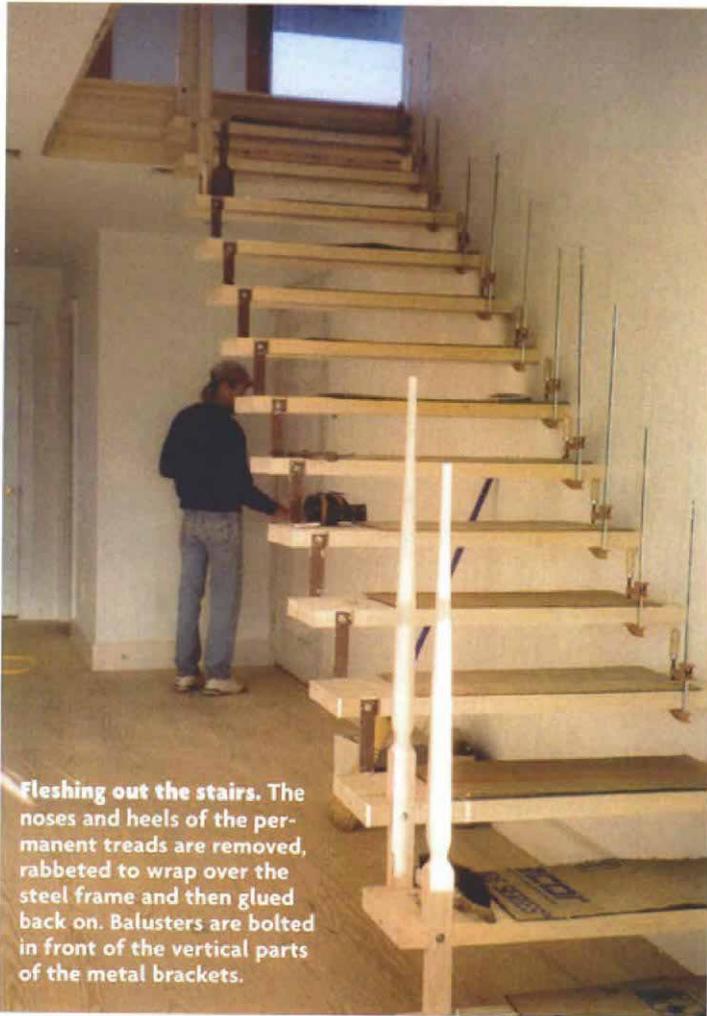
Fleshing out the stairs. The noses and heels of the permanent treads are removed, rabbeted to wrap over the steel frame and then glued back on. Balusters are bolted in front of the vertical parts of the metal brackets.

To my surprise and relief, most of the holes actually lined up. Quarter-inch threaded rod with a nut and washer on each end captured the treads between opposing steel-bracket sections. I rabbeted the nose and heel pieces to house the steel and counterbored holes for the nuts and washers. The pieces were then glued back on (photo above).

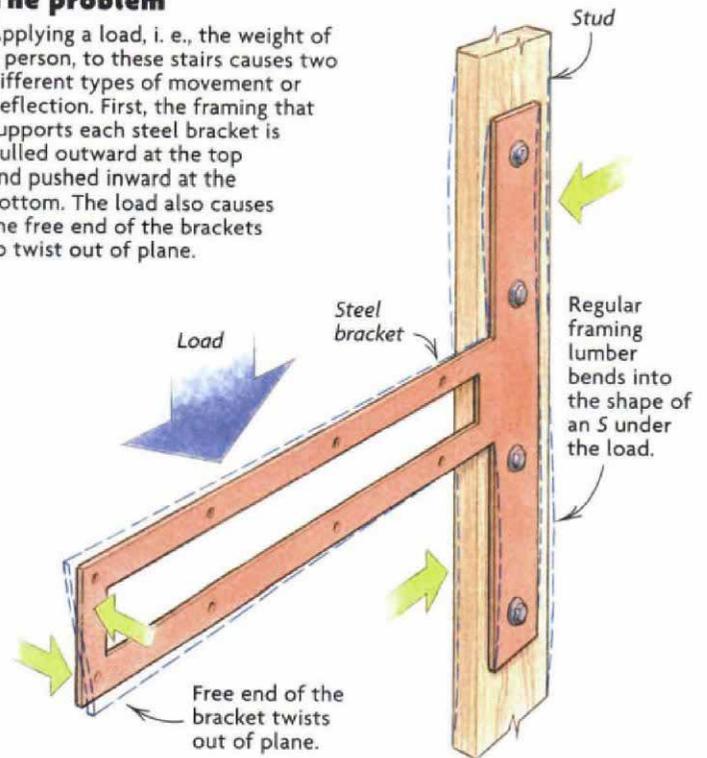
The problem

Applying a load, i. e., the weight of a person, to these stairs causes two different types of movement or deflection. First, the framing that supports each steel bracket is pulled outward at the top and pushed inward at the bottom. The load also causes the free end of the brackets to twist out of plane.

Careful observation showed that the steel itself performed as expected, but there were two unexpected problems (drawing pp. 72-73). First, the wall studs were deflecting in an S pattern, and second, the cantilevered ends of the steel brackets were twisting out of plane.

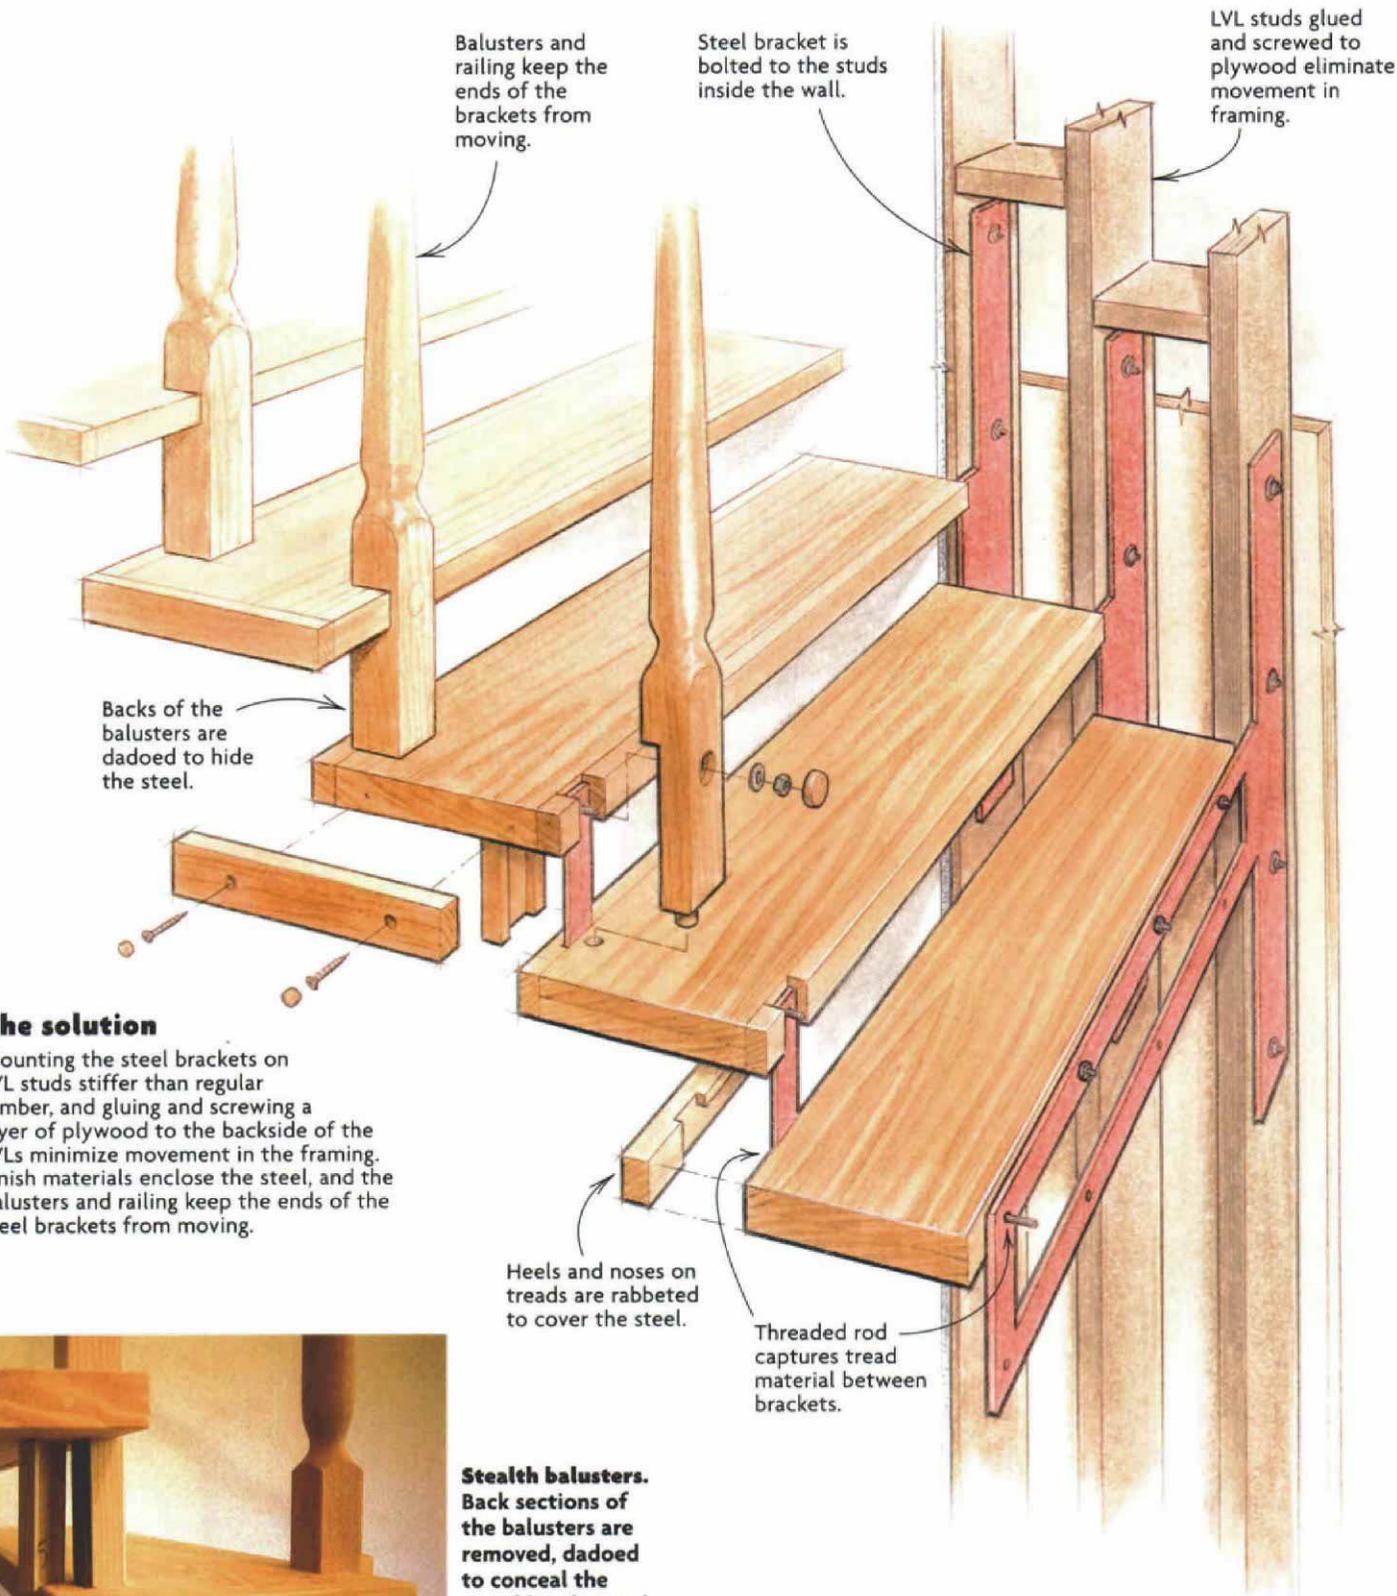
The solution

Mounting the steel brackets on LVL studs stiffer than regular lumber, and gluing and screwing a layer of plywood to the backside of the LVLs minimize movement in the framing. Finish materials enclose the steel, and the balusters and railing keep the ends of the steel brackets from moving.

We eliminated stud deflection by replacing the standard 2x6 studs with 1 $\frac{3}{4}$ -in. by 5 $\frac{1}{2}$ -in. laminated-veneer lumber (LVL). Also, the plate that fastened the steel box bracket to the stud was lengthened to 48 in. with $\frac{1}{2}$ -in. dia. through bolts in zero-clearance holes. We also decided to glue and screw a $\frac{3}{4}$ -in. plywood skin to the backside of the studs so that the load was distributed to more than one stud.

The other contribution to deflection was more subtle, a result of the steel twisting out of plane when load was applied. The addition of balusters and handrail would keep the cantilevered end of the steel bracket from twisting, eliminating this movement. The handrail-baluster system was no longer just a code requirement and concession to safety: It became a structural necessity.

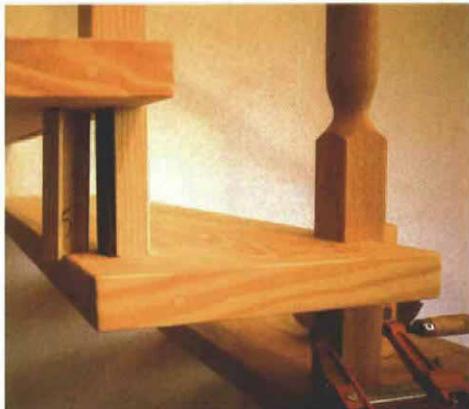
Stealth balusters. Back sections of the balusters are removed, dadoed to conceal the metal bracket and then reattached. Special care was taken to match the cutoff with the correct baluster.

We turned the balusters from 2x2 ash blanks. We left the baluster bottoms square for 9 in. and then cut a $\frac{3}{4}$ -in. by $5\frac{11}{16}$ -in. section (distance between the treads) from this square part (photo facing page). These pieces that we cut off the balusters were dadoed to cover the steel and then glued back on in one of the final steps.

Again, we paid careful attention to getting each of these pieces back on the baluster that it was cut from, which left the joint pretty much invisible. The outside tread bolt also passes through the baluster. We counterbored a hole for the nut and washer, which was then hidden by a plug, or bung as my new friends on the East Coast have insisted on calling it.
